RESEARCH MEMORANDUM

FLIGHT-TEST MEASUREMENTS OF AILERON
CONTROL SURFACE BEHAVIOUR AT
SUPERCRITICAL MACH NUMBERS

April 23, 1947

NACA RM No. A7A15

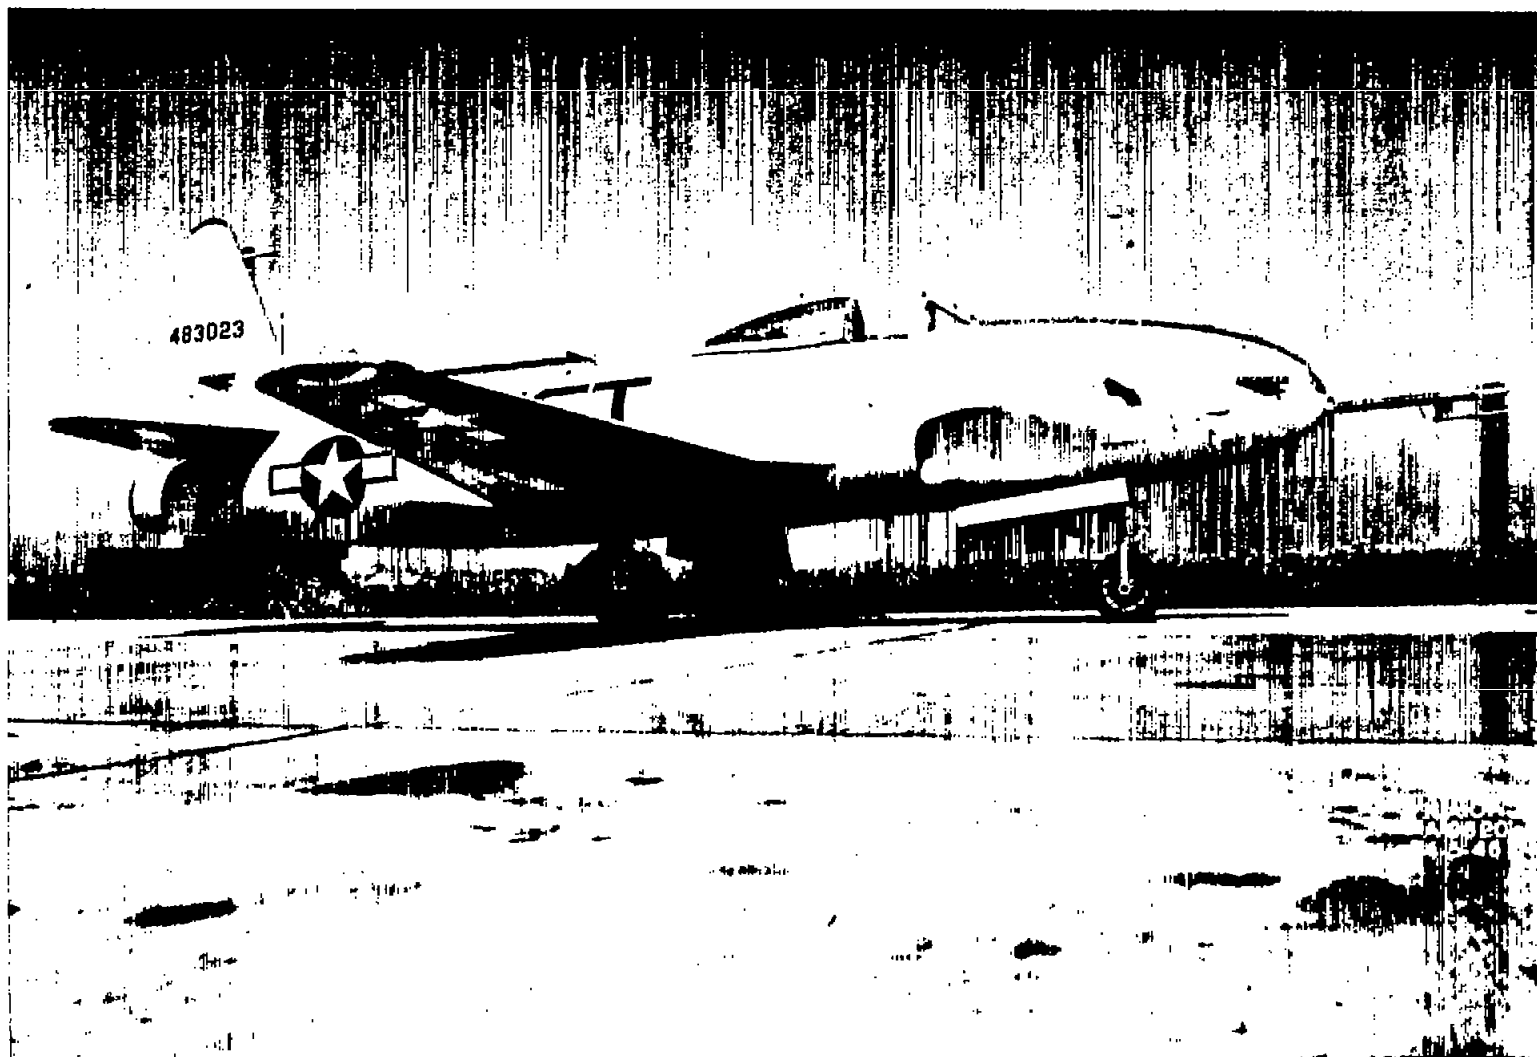
FIG. 2

Figure 2.- Side view of the test airplane as instrumented for flight tests.

The tests were conducted on the turbojet-propelled fighter airplane shown in the three-view drawing. (See fig. 1.) Figures 2 and 3 are side-view and plan-form photographs, respectively, of the airplane as instrumented for flight tests.

The static pressures used in computing the values of Mach number and pressure coefficient were obtained by correcting the static pressure at the free-swivelling airspeed head mounted on the right-wing tip (fig. 2) for position error as determined from a low-altitude flight calibration. In addition, the error inherent in the airspeed head itself due to compressibility was determined from a calibration made in the Ames 16-foot high-speed wind tunnel and corrections were made. The airspeed recorder, altimeter, and all other pressure cells were calibrated at several temperatures to permit removal of temperature effects from the data. The accuracy of the data is as follows:
